CUTTING TOOL ENGINEERING

PRODUCTIVE TIMES

Saving Spindles

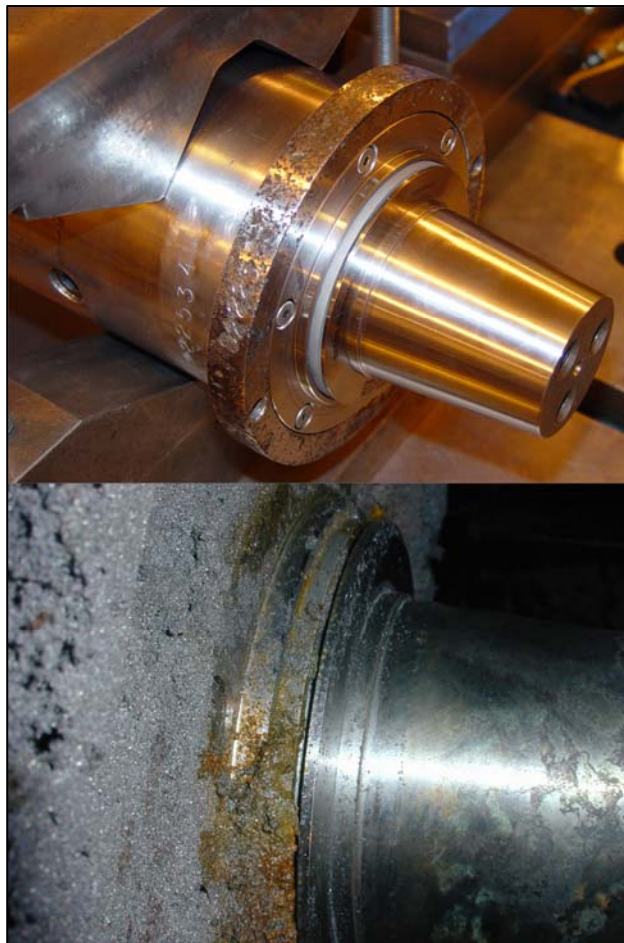
After 3 years in a grinding application at Peerless (bottom), this AirShield spindle seal continues to operate without failure.

The "self-contained" Universal AirShield is a retrofitable cartridge seal for problem applications like Peerless Saw was experiencing. In addition, the air-purge seal that uses regulated air pressure and a flexible lip seal to prevent coolant and contaminants from entering the spindle.

It has now been three years since Peerless first installed on a failing grinder, which is still running without any contamination issues. Gase said: "Our investment to retrofit our spindle with the Universal AirShield has saved us thousands of dollars in spindle rebuilds and reduced our maintenance costs, while increasing productivity. Since that time, several other machines were retrofitted with AirShields and not one has failed. I am sure we will eventually have all nine of our grinders operating with the AirShield spindle seals."
